In-flight evolution of EIT

Extrême-ultraviolet
Imaging
Telescope

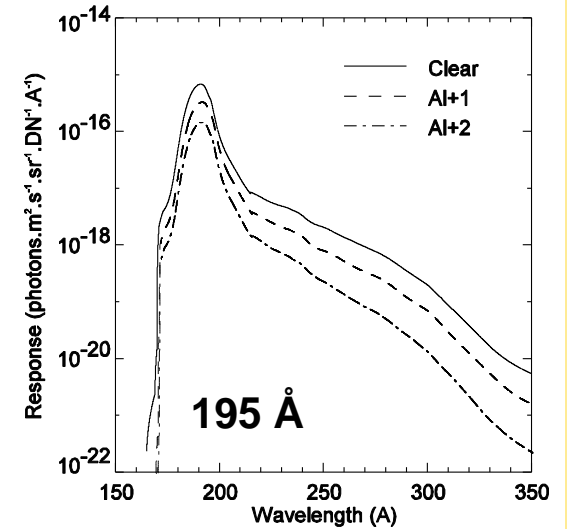
Spectral Selectivity

Molybdenum-Silicon multilayers tuned to different λ

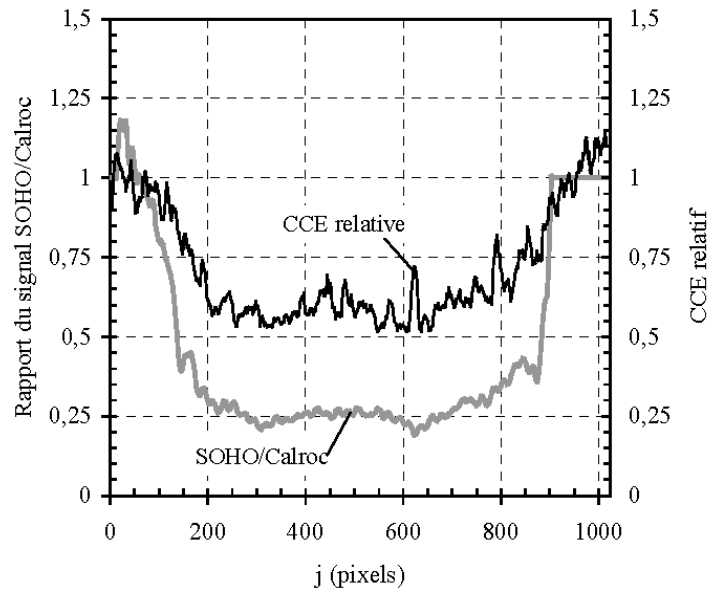
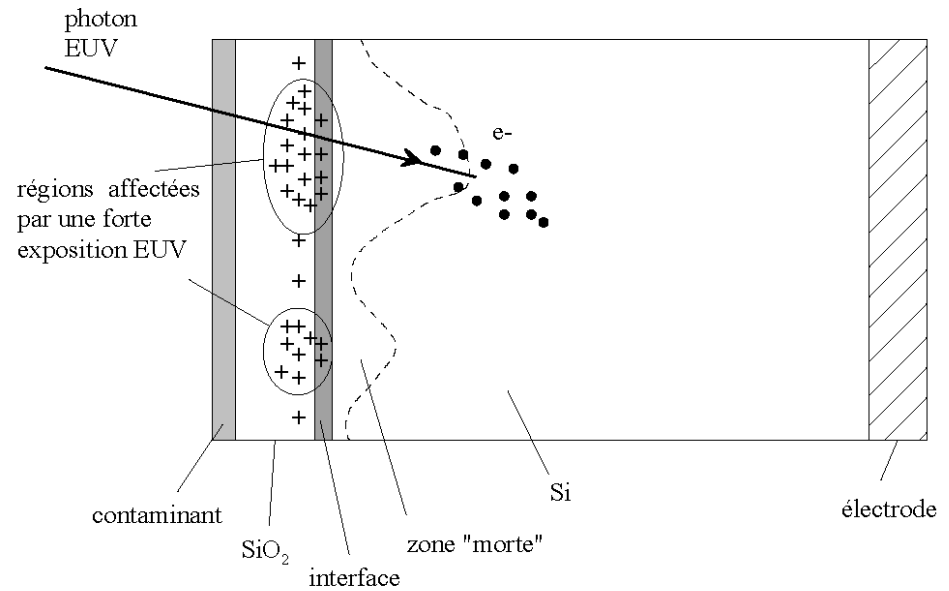
Cause of sensitivity loss: CCE + water
